Visualizing the May 22, 2011, Joplin, Missouri, Tornado path using building permits

Abstract

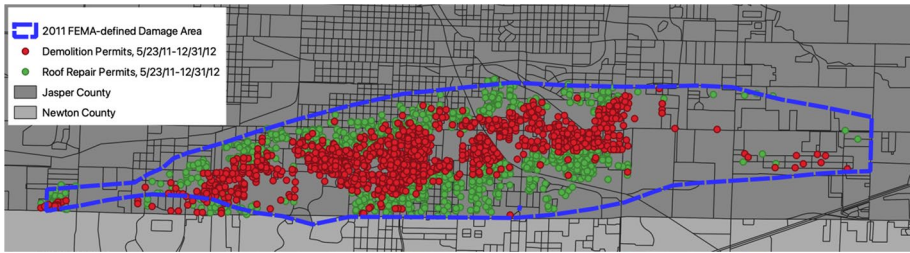
Fig. 7 Roof repair and demolition permits, 2011–2012

First, roof repair and demolition permits were plotted (Fig. 7). Demolition permits (May 23, 2011–December 31, 2012) ran along the path's centerline, describing the area of heaviest damage. Roof repair permits (matching period) skirted the catastrophic damage zone and mainly occupied the periphery as established by the demolition permits. The emergent pattern indicated that sufficient data on demolition permits in the wake of a significant tornado may act as a proxy for the zone of heaviest destruction, while roof repair permit data can be utilized to delimit the areas least affected by the event.

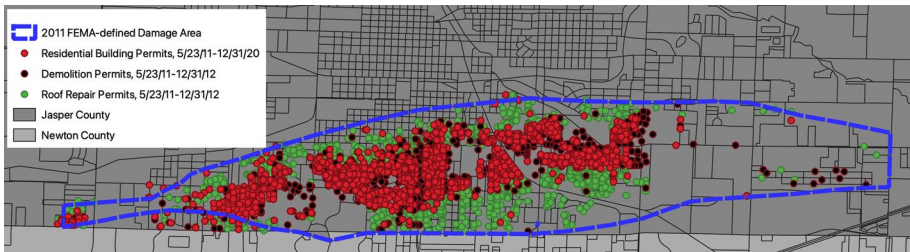
Fig. 8 Residential rebuilding 2011–2020, roof repair and demolition permits, 2011–2012

Next, demolition and roof permits (again, from May 23, 2011–December 31, 2012; Fig. 8) were displayed alongside residential building permits (May 23, 2011–December 31, 2020). In a similar configuration, residential building permits gathered primarily in the center of the tornado's path and aligned well with the demolition data except for two noticeable pockets, one in the west-central and one in the east-central portion of the path—still-empty lots on which no rebuilding had occurred as of December 31, 2020 (verified by ground truthing, June 17–18, 2021). Roof repair data over the same period as above was again used here to display the peripheral areas where limited damage occurred.
